YOUR INSPECTION REPORT

1765 Anystreet Dr, Lithia, FL 3354799
Inspection prepared for: John Sample
Date of Inspection: 1/8/2018 Time: 1:00 PM
Age of Home: 2017 Size: 2400
Weather: Sunny 86
Order ID: 9412

Inspector: Bob Hintze
License #HI12
Riverview, FL

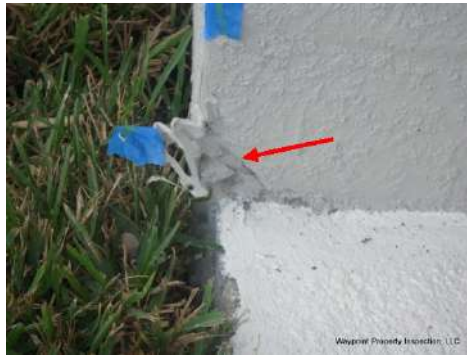
Damage was visible at the rear corner near patio.

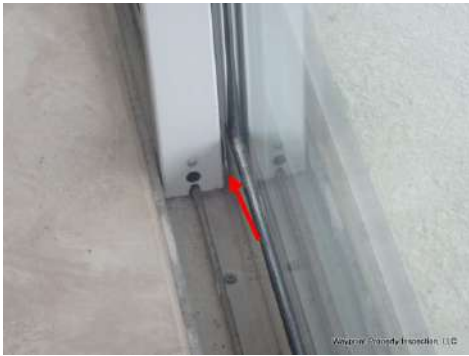
Sliding door had visible gaps at the base.

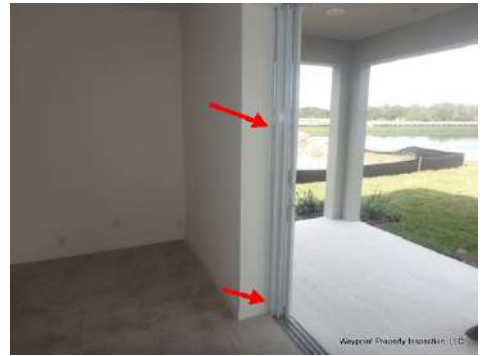
Sliding door was not level when doors were fully opened.

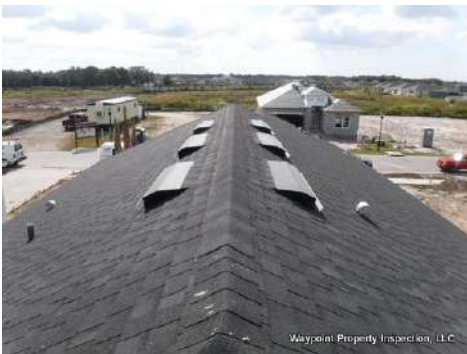
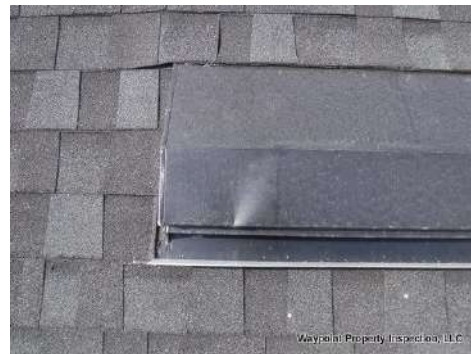
Roof vent had minor damage.

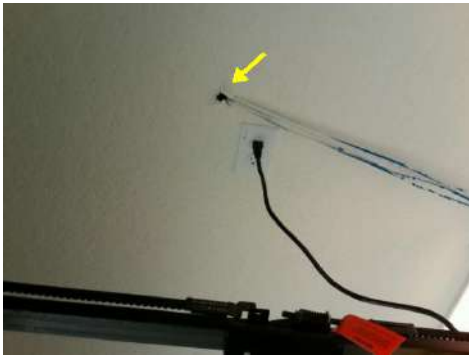
Holes/gaps should be sealed with fire rated sealant.

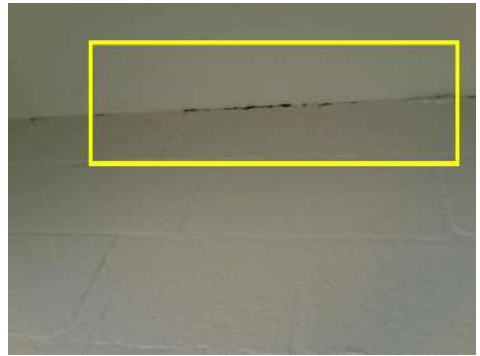
Holes/gaps should be sealed with fire rated sealant.

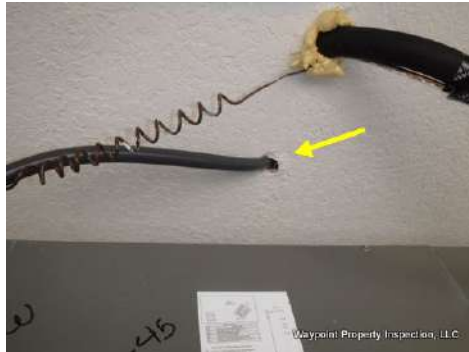
Holes/gaps should be sealed with fire rated sealant.

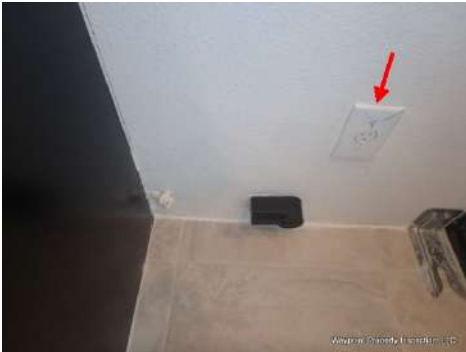
Cover plates were damaged at kitchen oven/stovetop.

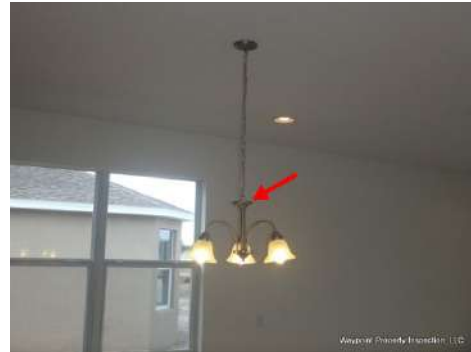
Light fixture was not level.

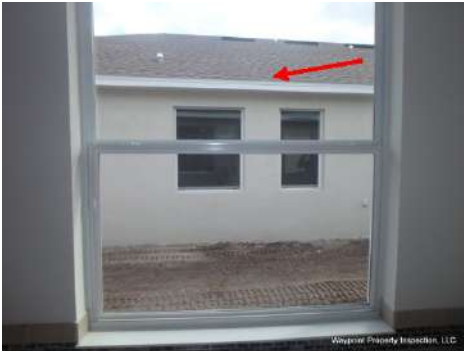
Windows had scuffs at the master bedroom and master bathroom.

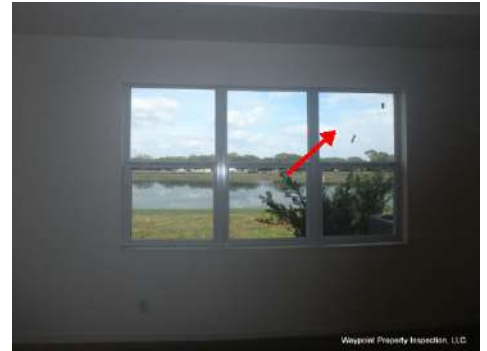
Windows had scuffs at the master bedroom and master bathroom.

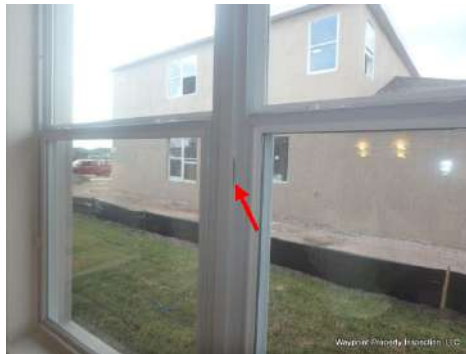
Window was damaged at the kitchen dining area.

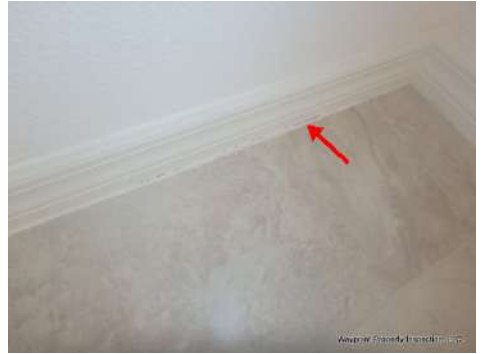
Baseboards should be caulked at the dining room.

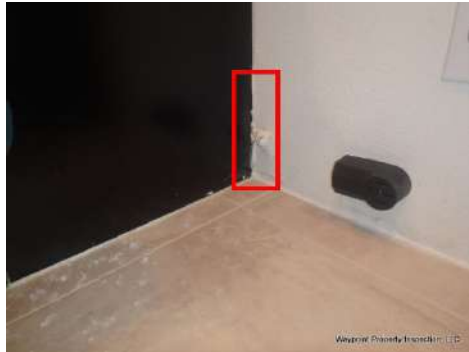
Wall at kitchen range gas piping should be sealed.

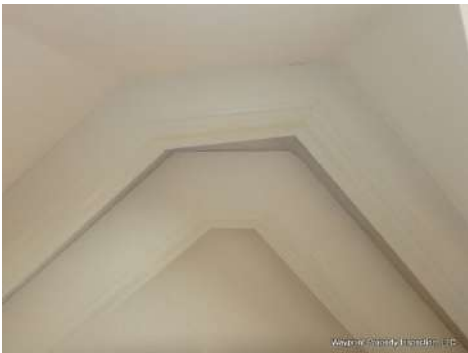
Entry rotunda had poor finish and crown molding/trim was uneven.

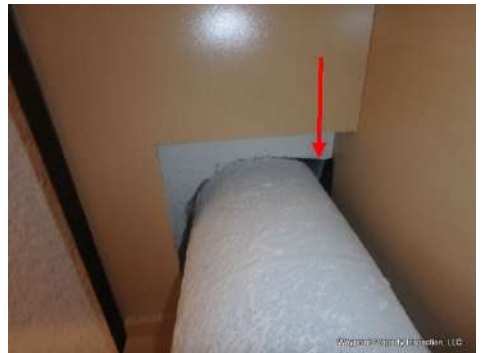
Gaps around kitchen ventilation should be sealed. Visible insulation was fell through.

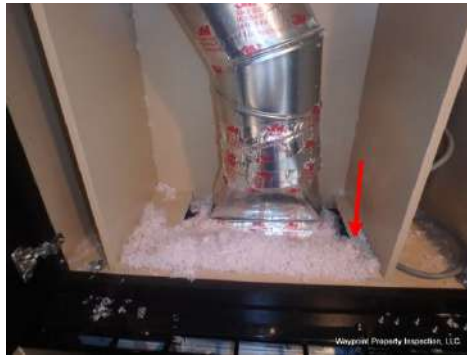
Gaps around kitchen ventilation should be sealed. Visible insulation was fell through.

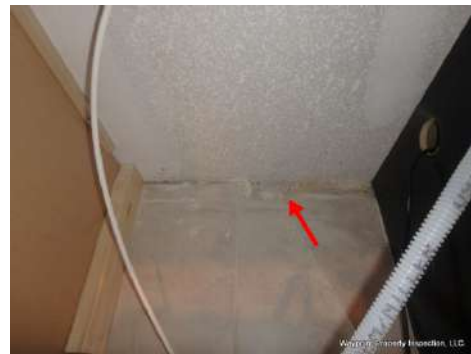
Tile was not installed behind the dishwasher.

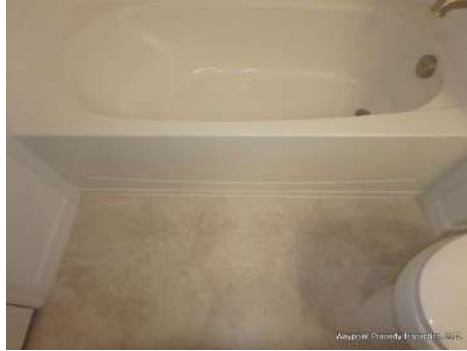
Bathtub trim was loose at hallway bathroom (rear) and hallway bathroom (front).

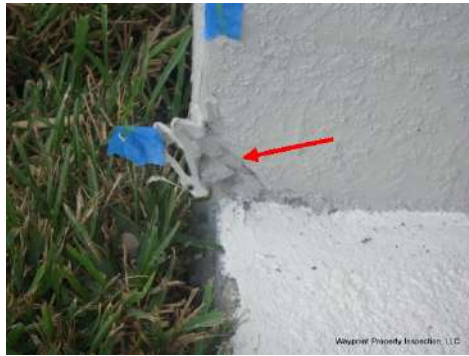
Damage was visible at the rear corner near patio.

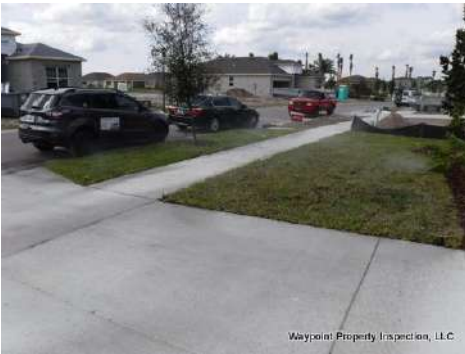
Sprinkler heads should be adjusted for proper coverage.

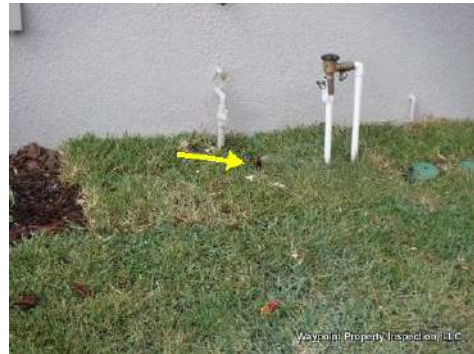
Sprinkler heads should be adjusted for proper coverage.

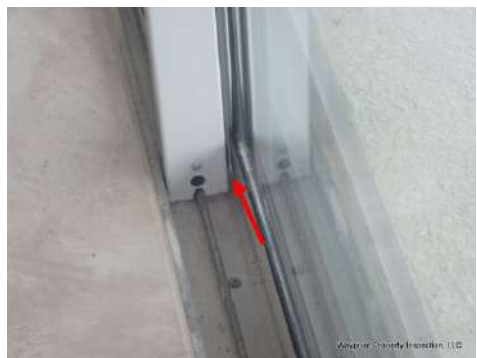
Sliding door had visible gaps at the base.

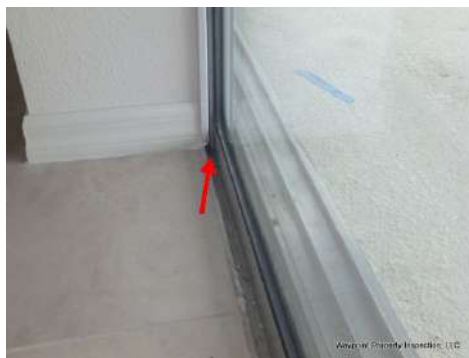
Sliding door had visible gaps at the base.

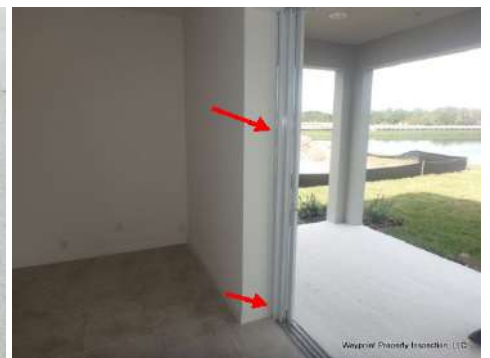
Sliding door was not level when doors were fully opened.

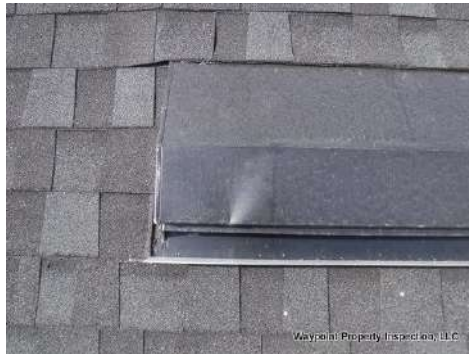
Roof vent had minor damage.

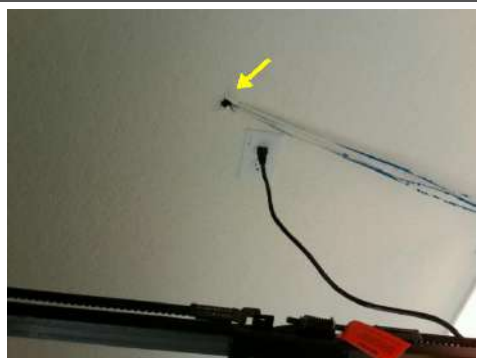
Holes/gaps should be sealed with fire rated sealant.

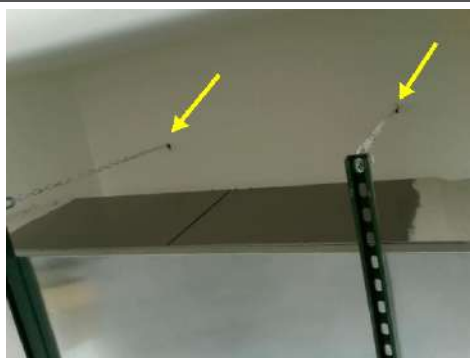
Holes/gaps should be sealed with fire rated sealant.

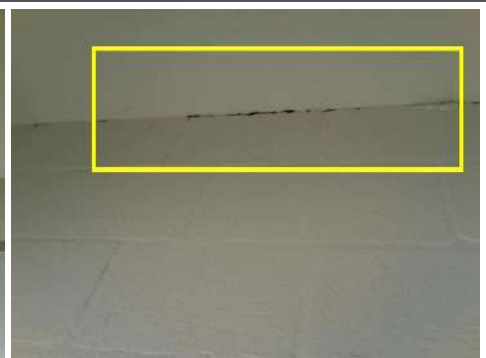
Holes/gaps should be sealed with fire rated sealant.

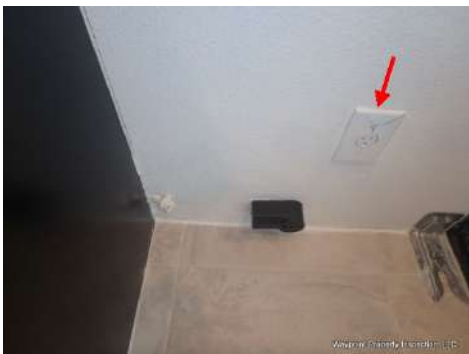
Cover plates were damaged at kitchen oven/stovetop.

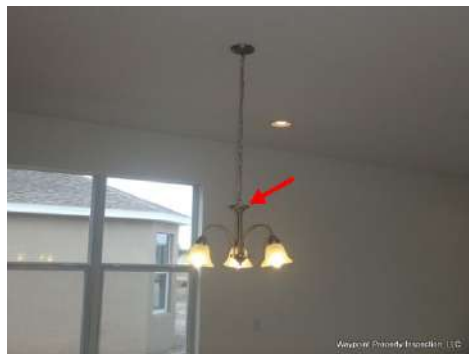
Light fixture was not level.

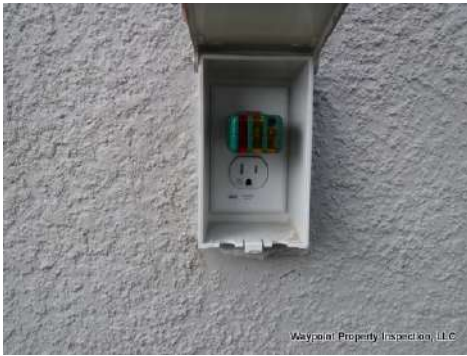
GFCI outlets did not operate when tested at exterior right side and rear outlets.

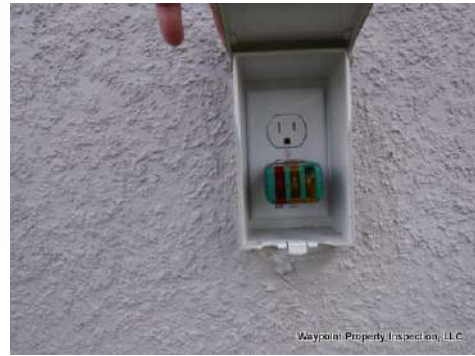
GFCI outlets did not operate when tested at exterior right side and rear outlets.

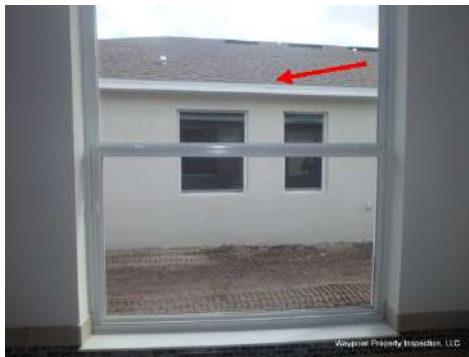
Windows had scuffs at the master bedroom and master bathroom.

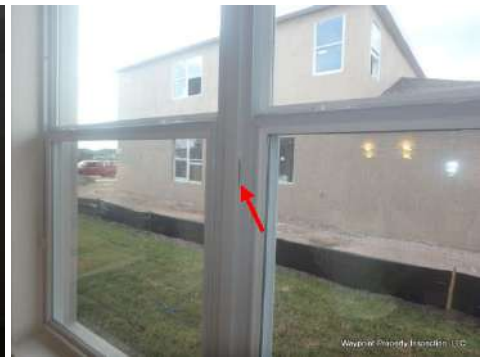
Window was damaged at the kitchen dining area.

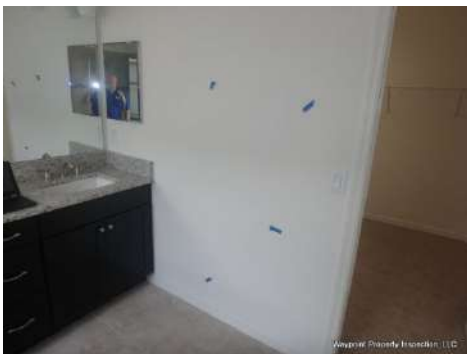
Walls needed touchups at various areas.

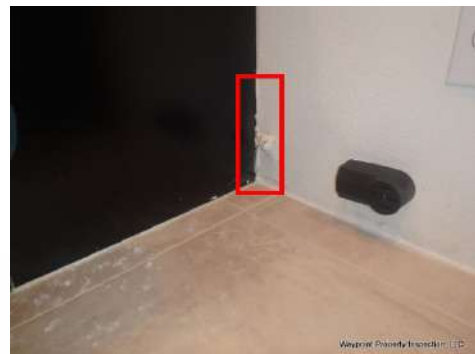
Wall at kitchen range gas piping should be sealed.

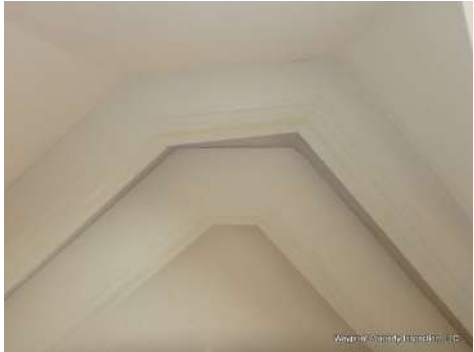
Entry rotunda had poor finish and crown molding/trim was uneven.

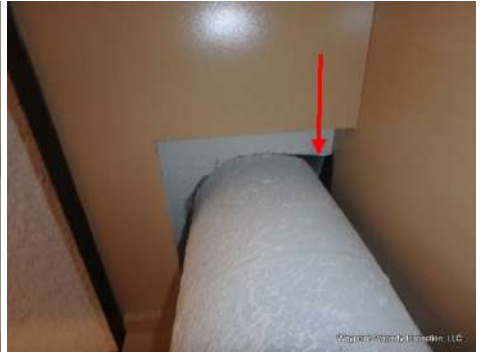
Gaps around kitchen ventilation should be sealed. Visible insulation was fell through.

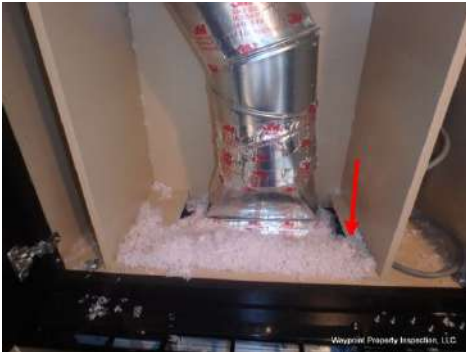
Gaps around kitchen ventilation should be sealed. Visible insulation was fell through.

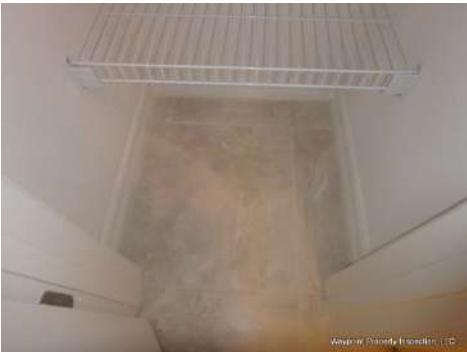
Flooring had paint splatter at the front hallway bathroom closet.

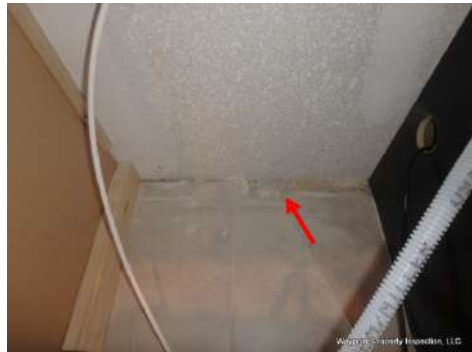
Tile was not installed behind the dishwasher.

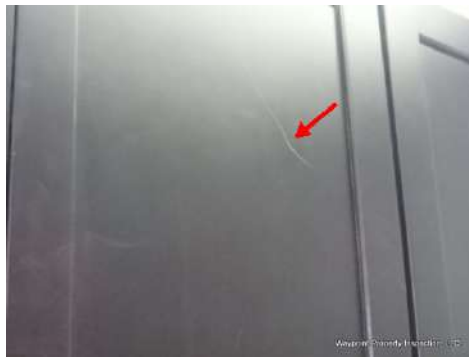
Cabinet doors were scuffed/scratched.

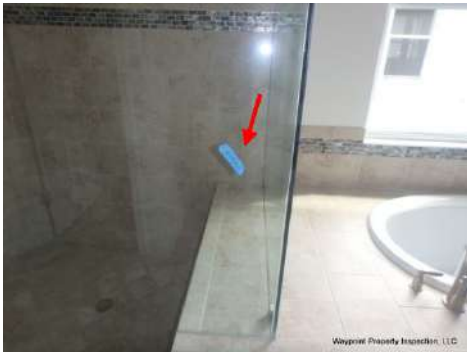
Shower enclosure glass appeared scratched at master bathroom.
