Waypoint Property Inspection, LLC

Inspection 1: Foundation/Grounds, Pre-Block Construction

Property Address: 3009 Anystreet Dr, Dover, FL Date: 1-07-2018 Time: 1:00pm

Block: Builder: Big Builder Lot#: 63

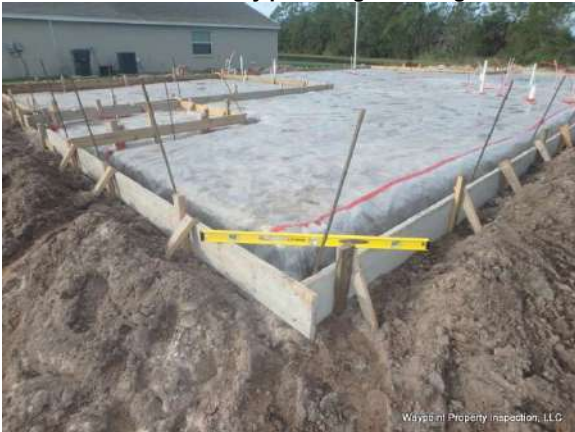
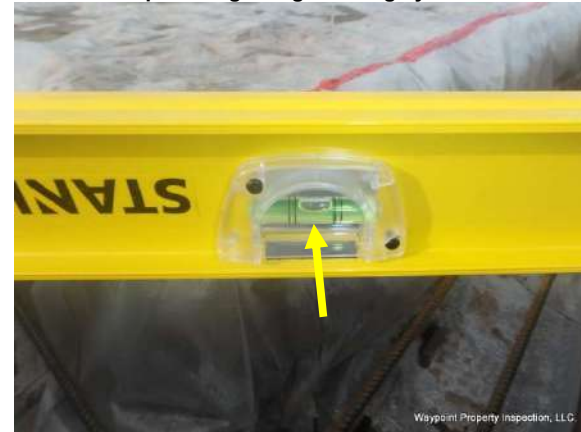
Concrete form measured level at various areas

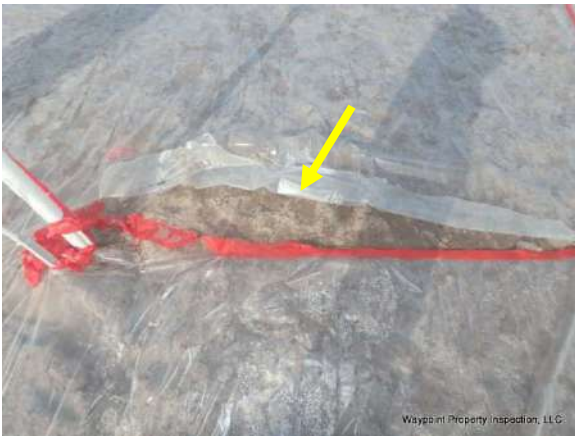
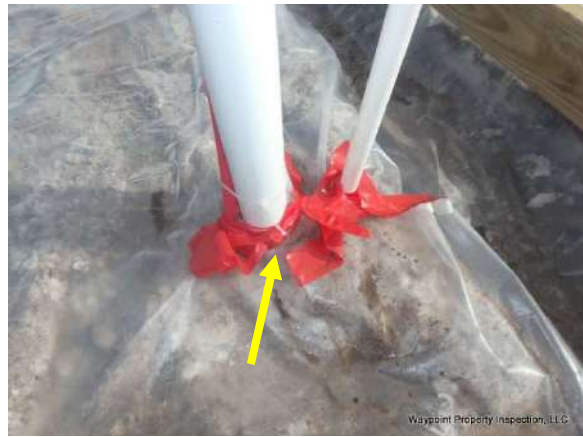
- Garage and rear porch/deck level were slightly pitched correctly for drainage.
- Rebar (wall support) is properly spaced at no more than 48" at perimeter walls.
- Inspected pre-plumbing areas (exterior, kitchen, baths, and laundry.) Found no defects.
- Vapor barrier taped seams had visible gaps that should be sealed
- 01/18 Post slab: Rebar at the porch area had visible gap and should be sealed.

Vapor barrier had visible gaps that should be sealed.

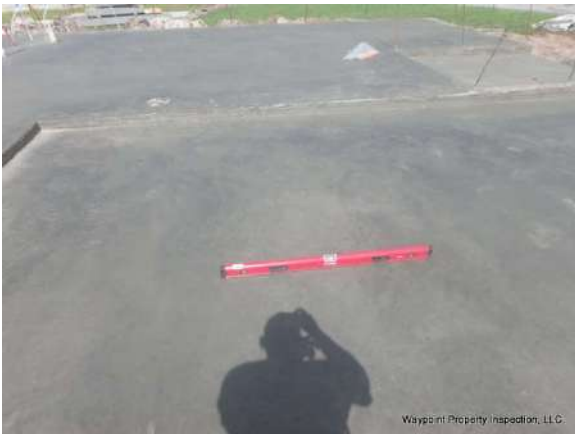
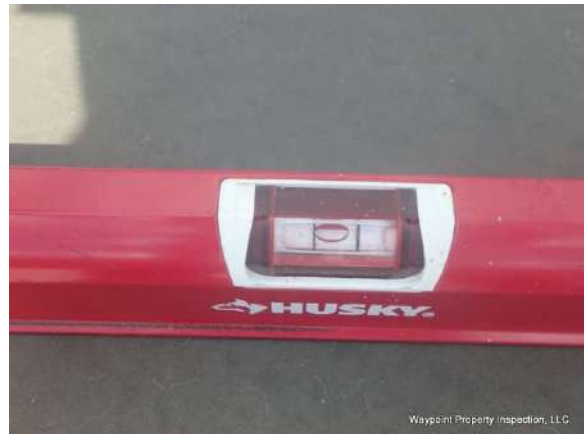
Garage had proper slight pitch toward the door area

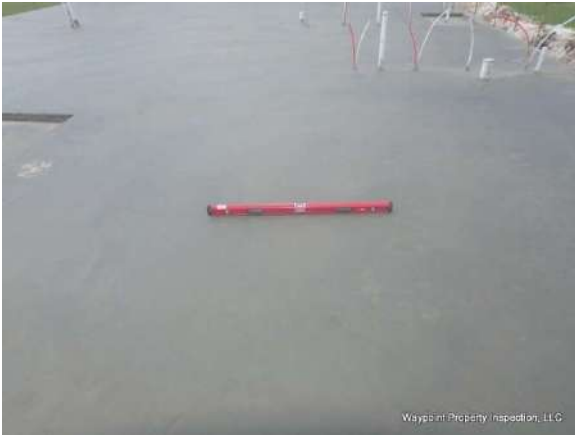
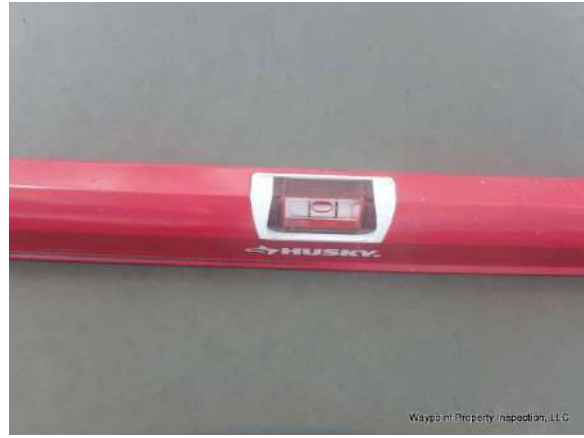
Foundation measured level at various areas.

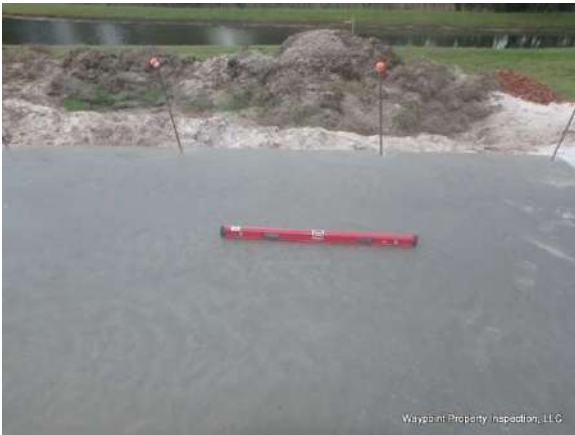
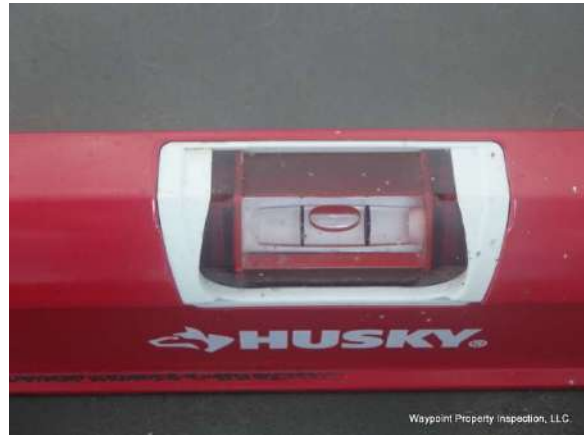
Foundation measured level at various areas.

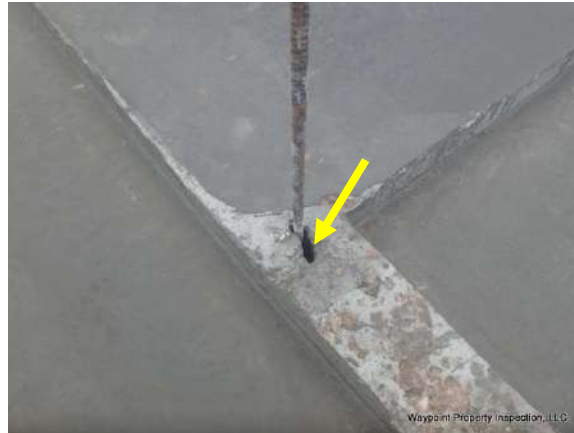
Rebar penetration at the porch area had visible gap
