YOUR INSPECTION REPORT

1765 Anystreet Dr, Lithia, FL 3354799
Inspection prepared for: John Sample
Date of Inspection: 1/8/2018 Time: 1:00 PM
Age of Home: 2017 Size: 2400
Weather: Sunny 86
Order ID: 9412

Inspector: Bob Hintze
License #HI12
Riverview, FL

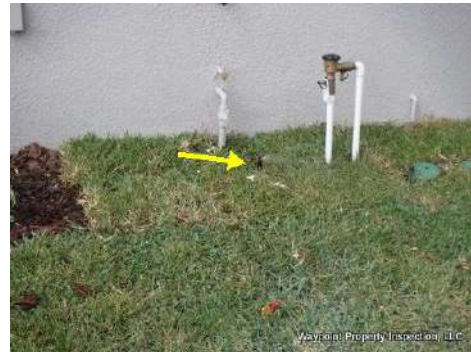
Sprinkler heads should be adjusted for proper coverage.

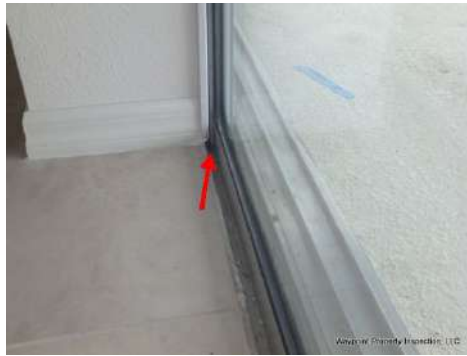
Sliding door had visible gaps at the base.

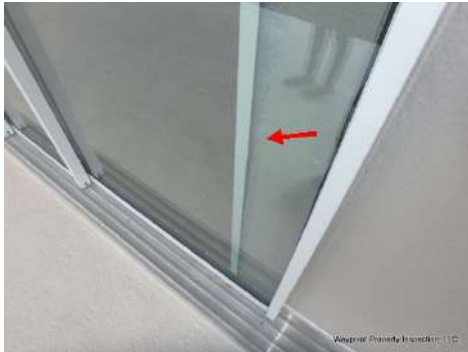
Sliding door jamb needed sealant and paint.

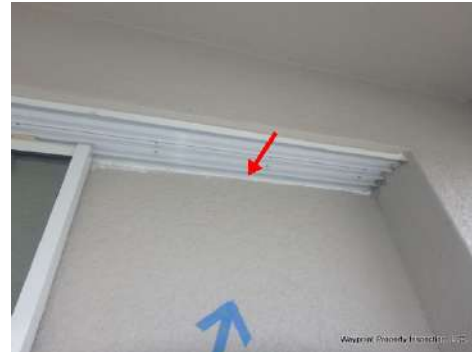
Sliding door jamb needed sealant and paint.

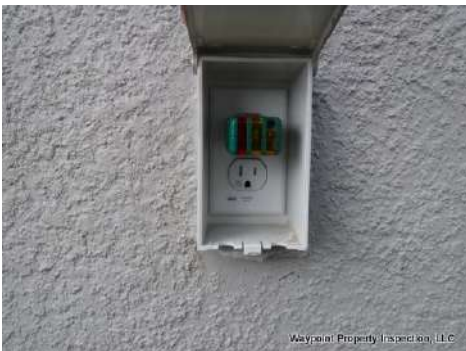
GFCI outlets did not operate when tested at exterior right side and rear outlets.

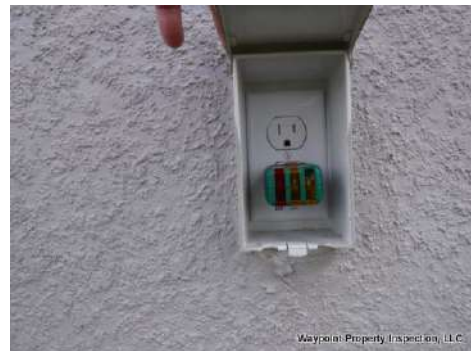
GFCI outlets did not operate when tested at exterior right side and rear outlets.

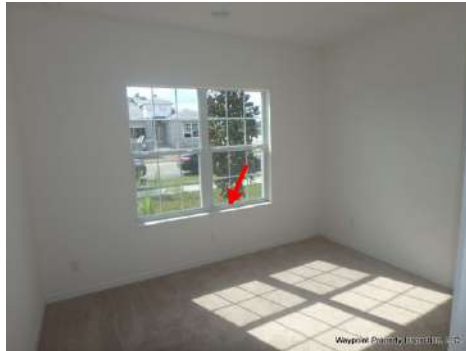
The interior and exterior of the windows should be sealed at various areas.

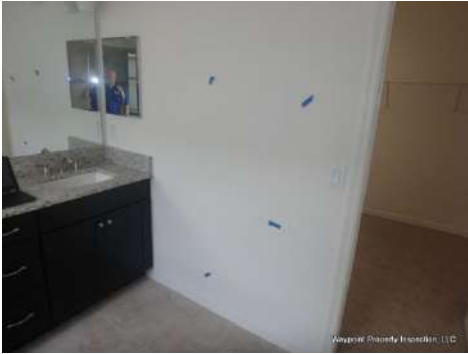
Walls needed touchups at various areas.

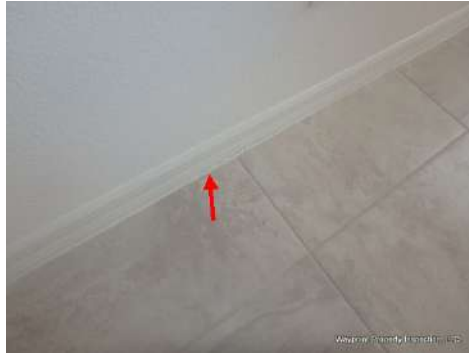
Baseboards should be caulked at the dining room.

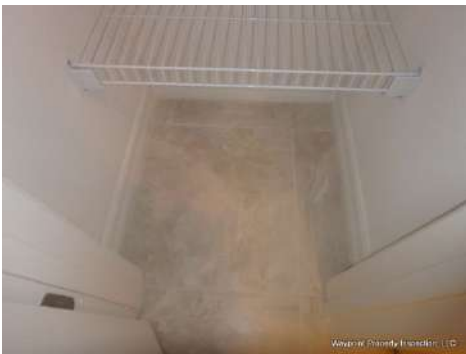
Flooring had paint splatter at the front hallway bathroom closet.

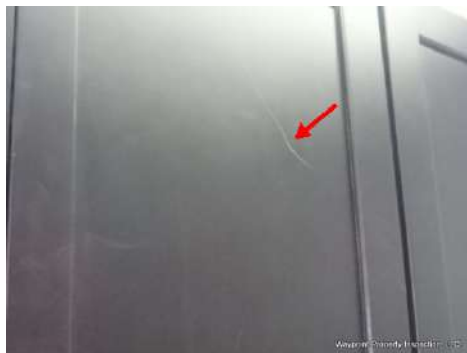
- Cabinet doors were scuffed/scratched.

Cabinet doors were scuffed/scratched.

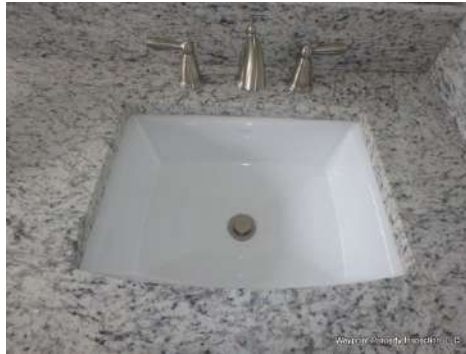
- Drain stopper was not functioning at master bathroom right side.

Drain stopper was not functioning at master bathroom right side.

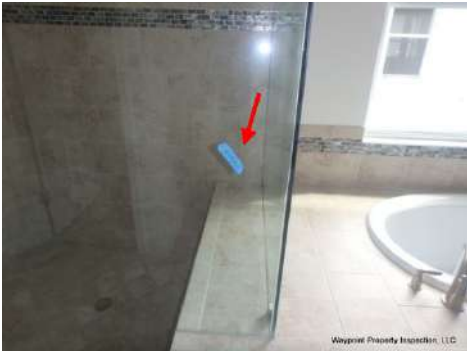
Shower enclosure glass appeared scratched at master bathroom.

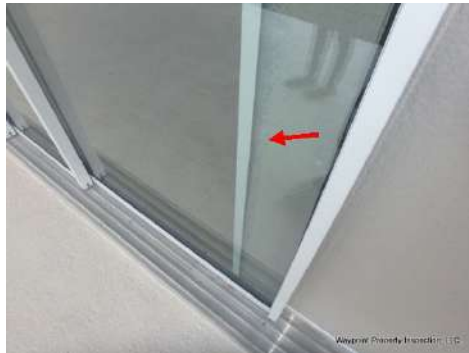
Sliding door jamb needed sealant and paint.

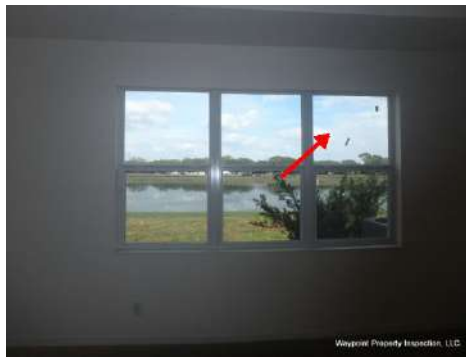
Windows had scuffs at the master bedroom and master bathroom.

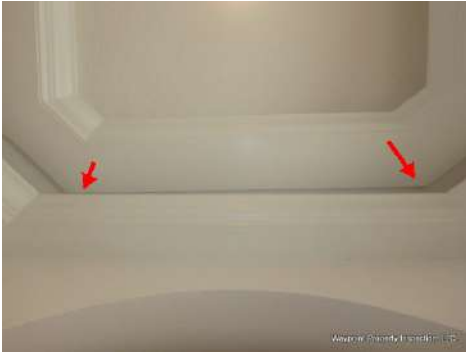
Entry rotunda had poor finish and crown molding/trim was uneven.

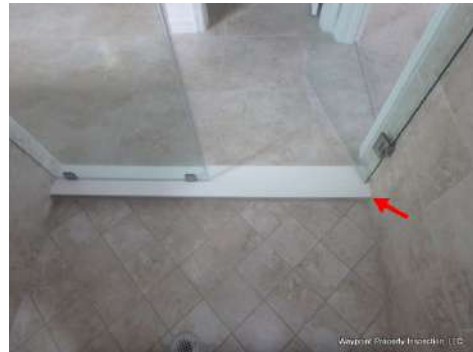
Grout was needed at shower walls at master bathroom.
