YOUR INSPECTION REPORT

1765 Anystreet Dr, Lithia, FL 3354799
Inspection prepared for: John Sample
Date of Inspection: 1/8/2018 Time: 1:00 PM
Age of Home: 2017 Size: 2400
Weather: Sunny 86
Order ID: 9412

Inspector: Bob Hintze
License #HI12
Riverview, FL

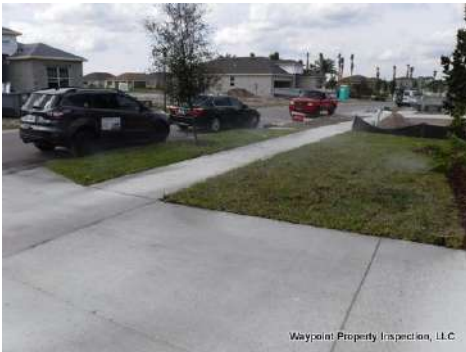
Sprinkler heads should be adjusted for proper coverage.

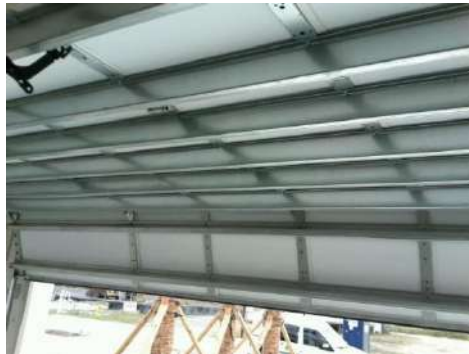
Vehicle door cyclical rating was not identified.

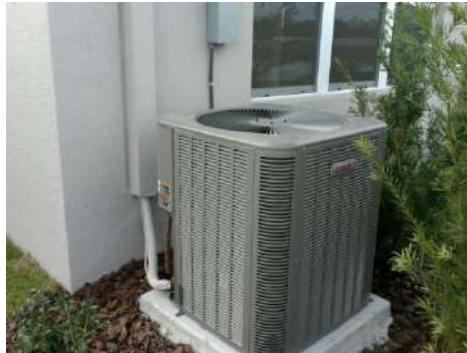
Cooling System

- Air temperature differential was 18 degrees. Per manufacturer guidelines, normal range should be 14-22 degrees.

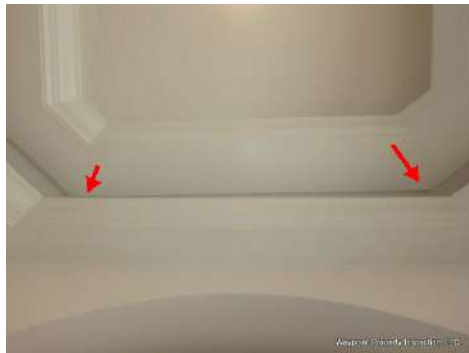
Entry rotunda had poor finish and crown molding/trim was uneven.

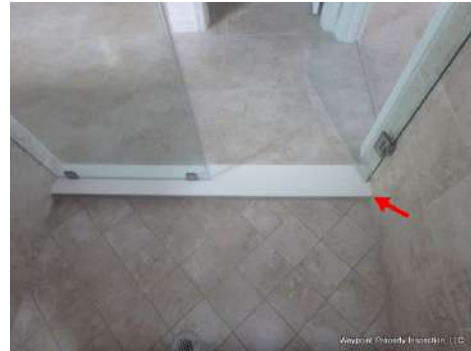
Grout was needed at shower walls at master bathroom.
